# Air disinfection

## ND Air 4820

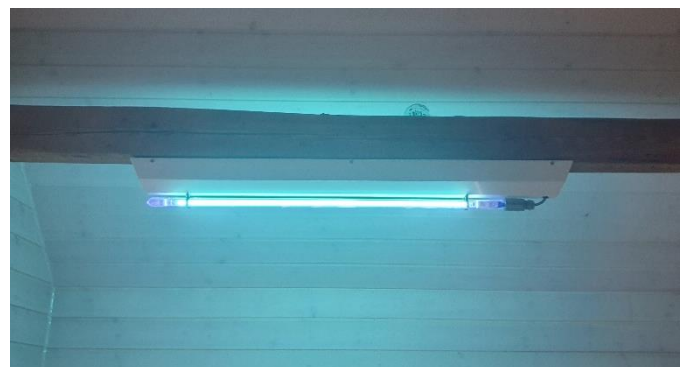
The UV unit is designed for mounting in ceiling or on walls. It is available in two versions;

- A model with external control box (maximum distance 5 meters to lamp)
- A model with a built-in power supply (picture) where the system is mounted in luminaire and can be connected to the lamp outlet and controlled externally with standard cabling.

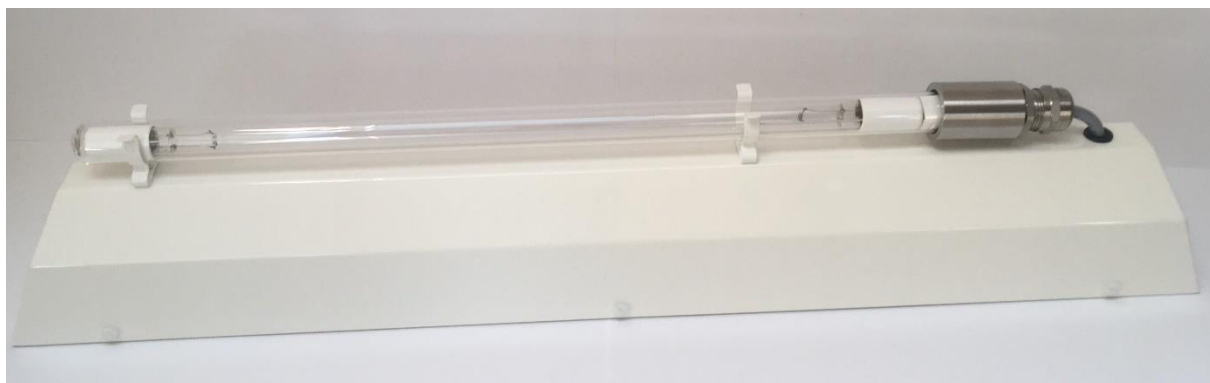
The UV lamps are known for a long lifetime, a high degree of disinfection, and low energy consumption. Configuration of the unit allows easy access to bulb replacement and other maintenance.

The lamps are designed for a lifetime of 10,000 hours, but this depends on the number of on/off and surroundings.

Type	ND Air 4820		
UVC-dose of 250 J/m <sup>2</sup>	1 meter for 4 min.	4 meters for 16 minutes	
UVC-dose of 750 J/m <sup>2</sup>	1 meter for 6 min.	4 meters for 44 minutes	
Bulb length	440 mm	Lifetime on bulb	10.000 timer
Luminaire external length	660 mm	Working temperature	10-40°C
Lamp function in control box	option	Number of lamps	1
Housing dimensions width	80 mm	Housing	IP 67
Housing dimensions height	95 mm	Electrical connection	240 V 50/60 Hz
Weight	1 kg	Power and fuse	48 W & 10 A
